# Service Letter

**SL:** 5239  
**Date:** 6 November 2008  
**Product:** Loader  
**Subject:** Improvements to First Generation Joystick Control

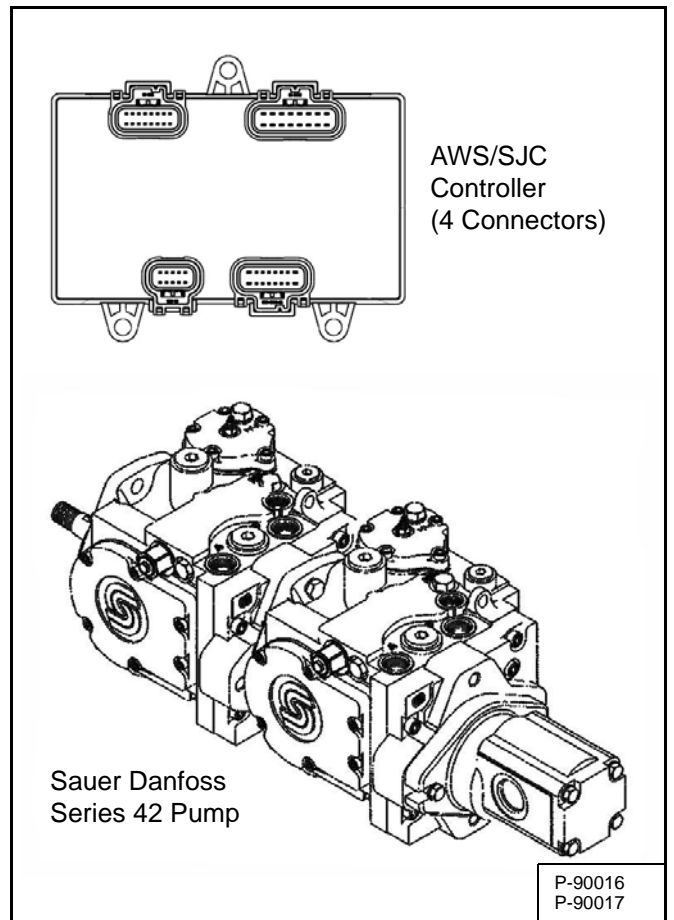
Figure 1

**[Figure 1]** First generation AWS and SJC design uses an “AWS/SJC Controller” and a Sauer Danfoss Series 42 hydrostatic pump. This is another way to identify a first generation loader.
